## CMS MOTORHOME INSPECTION FORM

Make & Model	Autocruise Starburst
Reg Number - NO GAP	FJ55AOA
HPI Clear	Yes
VAT	Yes
Engine Size	2.2
BHP	100
Transmission	Manual
Miles or KM	Miles
Mileage	64936
Confirm miles (within 5,000)	Yes
Is Mileage Warranted	Yes
Engine Keys Count	
V5 present	Yes

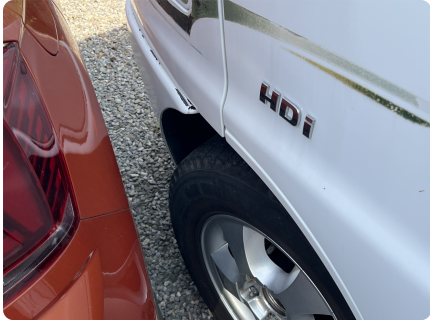
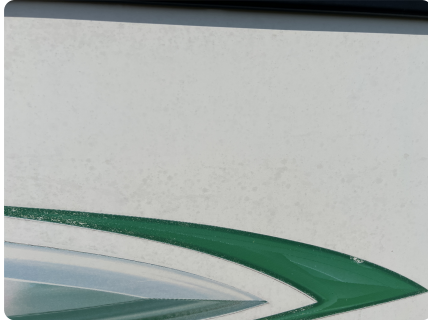
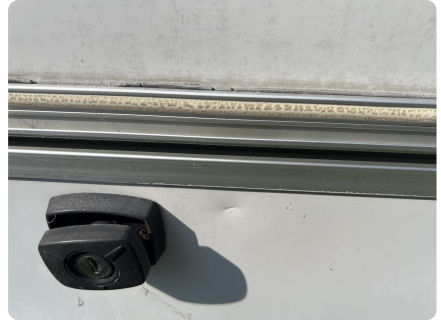
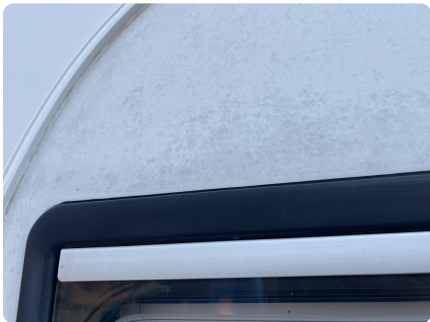
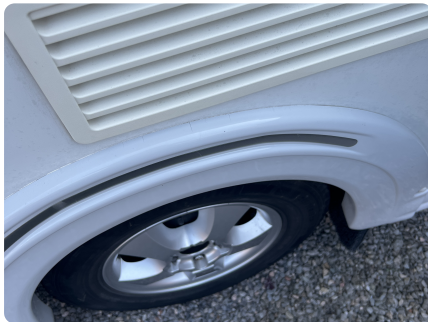
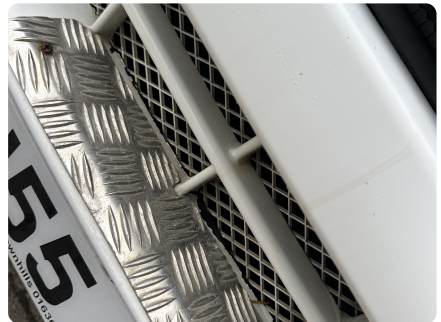
External Extras	Alloys, Awning, Electric step, Tv Aerial, Parking sensors
Decals	Need attention
Decals Further Info	Fading ns // fading passanger door // streaky os //
Any Damage Found	Yes
Damage Further Info	Paint flaking N/S/F bumper // oxidation on N/S and O/S // dink on O/S locker // crack N/S/R wheel arch // chequer plate on front bumper
Windscreen	Chip(s) larger than 10p
Alloy Wheels	Good
Alloy Wheels Further Info	
Tyres Illegal/Cracking/Out of Date	Yes
Tyre Further Info	Slight perishing NSR
Damp Floor Underneath	No
Damp Further Info	
Electric Step	Fully Working
Self Levelling Work	N/A
Pop Top Canvas Damage	N/A
