## CMS MOTORHOME INSPECTION FORM

Make & Model	Compass Avantgarde 400RI
Reg Number - NO GAP	LV02OVF
HPI Clear	Yes
VAT	No
Engine Size	2.0
BHP	110
Transmission	Manual
Miles or KM	Miles
Mileage	40338
Confirm miles (within 5,000)	Yes
Is Mileage Warranted	Yes
Engine Keys Count	
V5 present	Yes

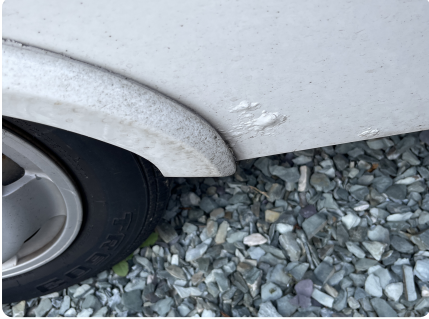
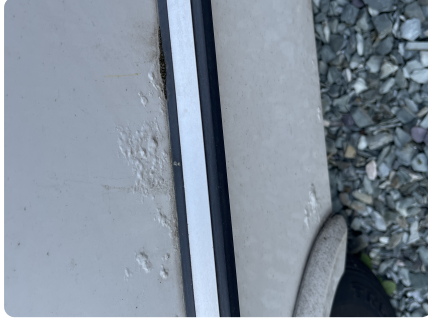
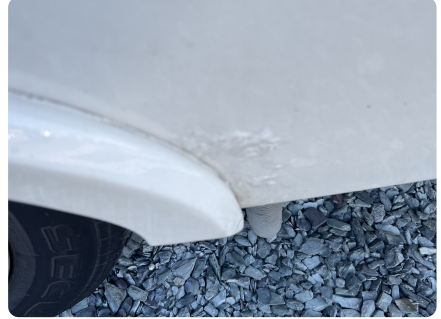
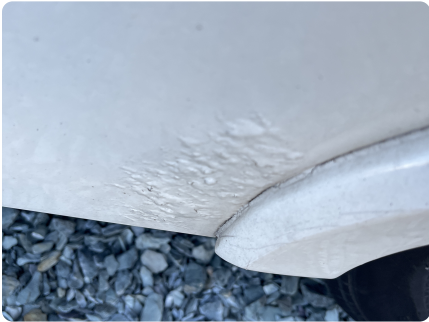
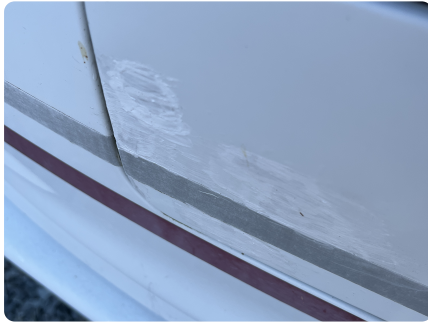
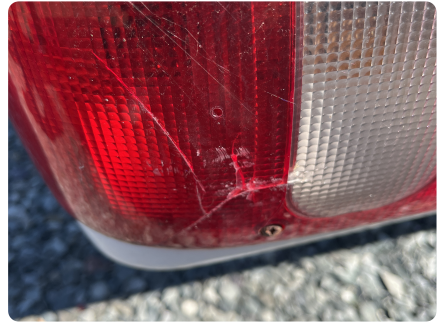
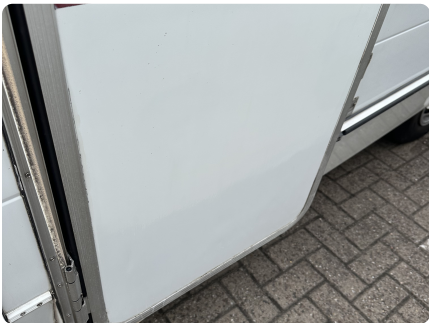
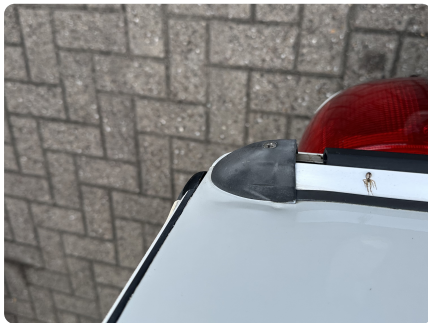
External Extras	Awning, Manual step
Decals	Need attention
Decals Further Info	Faded and cracking in areas
Any Damage Found	Yes
Damage Further Info	Rusting either side of rear nearside wheelarch // Poor repair to paintwork on fuel flap // Paint peel on bonnet // Rust to front & above rear offside wheelarch // N/S/R light cluster cracked // Crease on OSR corner // Crease on habitation door
Windscreen	No damage
Alloy Wheels	N/A
Alloy Wheels Further Info	
Tyres Illegal/Cracking/Out of Date	Yes
Tyre Further Info	Front tyres cracking slightly
Damp Floor Underneath	No
Damp Further Info	
Electric Step	N/A
Self Levelling Work	N/A
Pop Top Canvas Damage	N/A

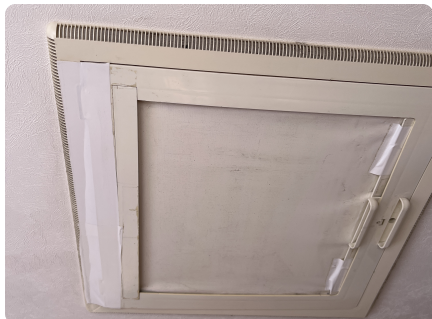
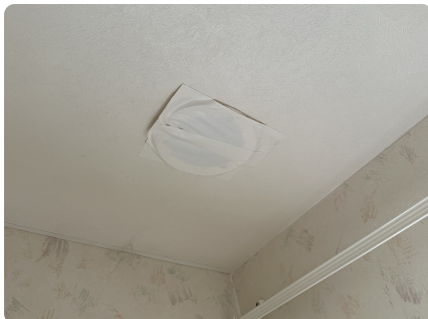
Internal Damage	Yes
Damage Info	Tape around edges of rear skylight // Tape around bathroom vent
Damp Visible/Soft	Yes
Damp Info	Visable damp NS overcab // OS overcab stained // Inside of toilet cassette door soft
Floor Damp/Spongy/Damaged	No
Manuals Present	Yes
