CMS MOTORHOME INSPECTION FORM

Make & Model	Elddis Autoquest 100
Reg Number - NO GAP	PX06CYT
HPI Clear	Yes
VAT	No
Engine Size	2.0
BHP	90
Transmission	Manual
Miles or KM	Miles
Mileage	42176
Confirm miles (within 5,000)	Yes
Is Mileage Warranted	Yes
Engine Keys Count	
V5 present	Yes

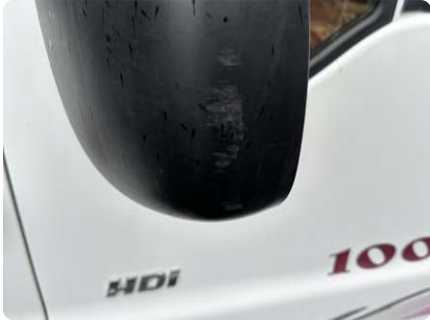
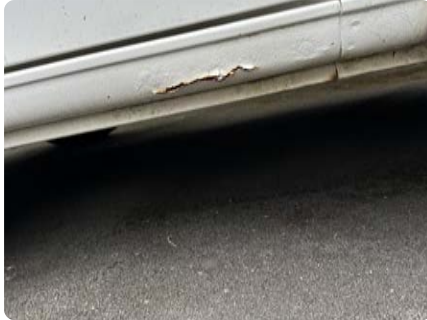
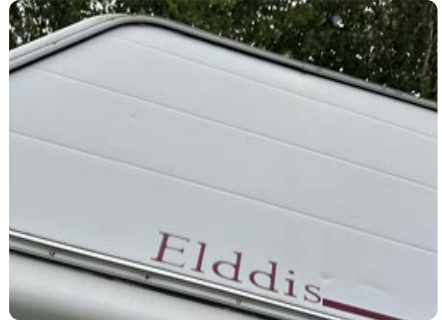
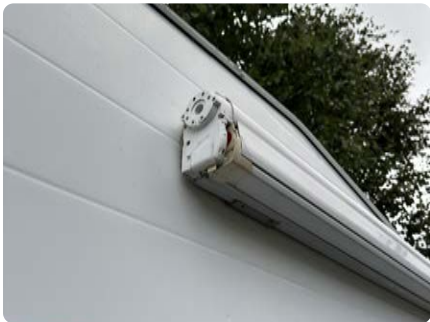
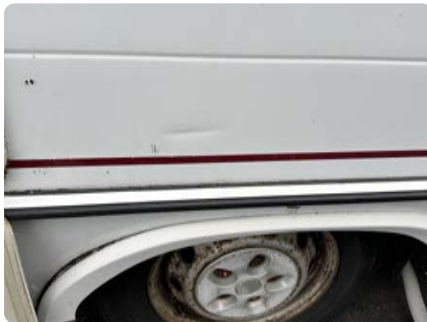
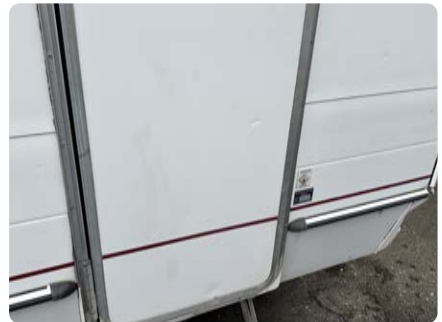
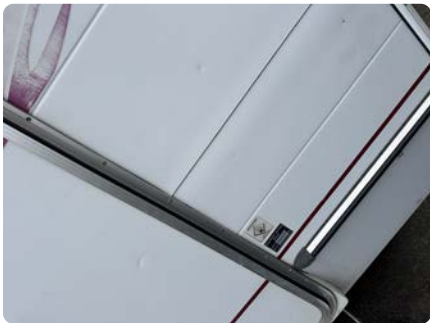
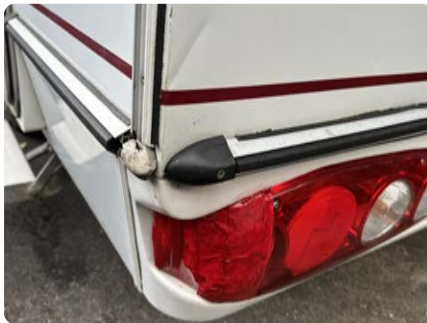
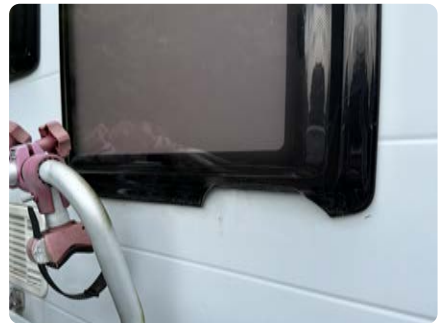
External Damage Photos

External Extras	Bike Rack, Manual step, Awning
Decals	Need attention
Decals Further Info	Faded on N/S // Overcab decal is torn
Any Damage Found	Yes
Damage Further Info	Scuff on N/S mirror plastic // Rust under passenger door // Dinks on N/S overcab // End cap missing off awning and Awning brackets are very loose// Scrape on N/S overcab wheel arch // Dinks on habitation door and N/S/R end // Damage to rear window //Damage to N/S/R light cluster and a scrape above // Several dinks on rear // Damage to O/S/R top corner // Crazing under front grill
Windscreen	No damage
Alloy Wheels	N/A
Alloy Wheels Further Info	
Tyres Illegal/Cracking/Out of Date	No
Tyre Further Info	
Damp Floor Underneath	No
Damp Further Info	
Electric Step	N/A
Self Levelling Work	N/A
Pop Top Canvas Damage	N/A

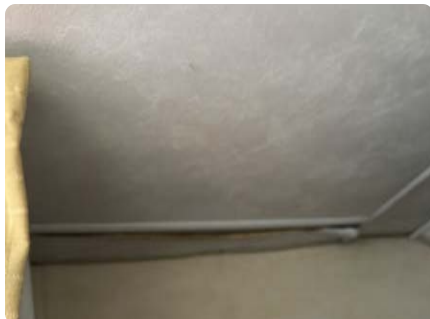
Photo 1

Internal Damage	Yes
Damage Info	Wallpaper coming away on N/S overcab
Damp Visible/Soft	Yes
Damp Info	N/S an O/S overcab has blue staining and pimpling // Staining down the N/S wall next to window // Staining on wall in N/S overhead lockers // Staining on N/S wall under bench seat // Staining and pimpling on O/S wall under window and around dinette // Pimpling next to habitation door // Leisure battery locker door is soft
Floor Damp/Spongy/Damaged	No
Manuals Present	Yes
