CMS MOTORHOME INSPECTION FORM

| Make & Model | Benimar Tessoro 483 |
| Reg Number - NO GAP | SF68OCN |

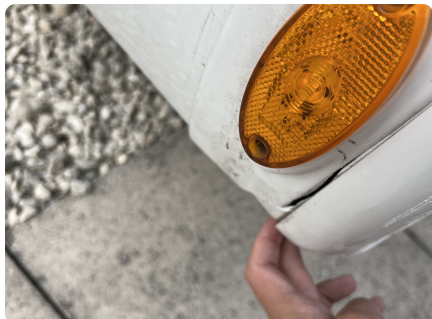
Photo 1

| Damage Further Info | Rear bumper ns cracked // crease in the rear panel // rear bumper os slight damage |
