## CMS MOTORHOME INSPECTION FORM

Make & Model	Elddis Autoquest 120
Reg Number - NO GAP	HX57RKF
HPI Clear	Yes
VAT	No
Engine Size	2.2
BHP	140
Transmission	Manual
Miles or KM	Miles
Mileage	36552
Confirm miles (within 5,000)	Yes
Is Mileage Warranted	Yes
Engine Keys Count	
V5 present	Yes

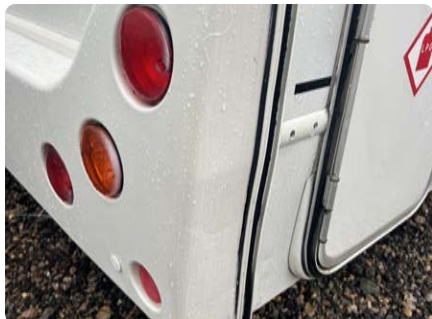
Photo 1

External Extras	Awning, Reversing camera, Tv Aerial, Bike Rack, Manual step
Decals	Good
Decals Further Info	
Any Damage Found	Yes
Damage Further Info	OSR previous repair
Windscreen	Chip(s) smaller than 10p
Alloy Wheels	N/A
Alloy Wheels Further Info	
Tyres Illegal/Cracking/Out of Date	No
Tyre Further Info	
Damp Floor Underneath	Yes
Damp Further Info	NSR Behind gas locker growing fungus
Electric Step	N/A
Self Levelling Work	N/A
Pop Top Canvas Damage	N/A

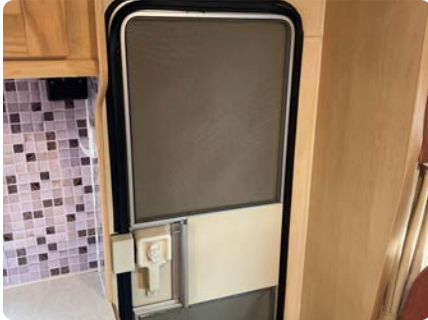
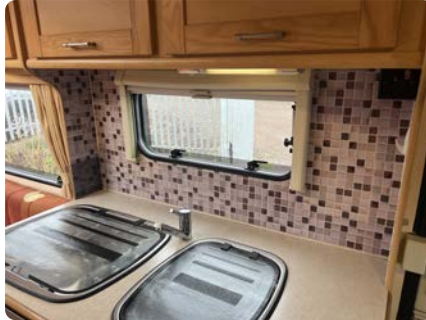
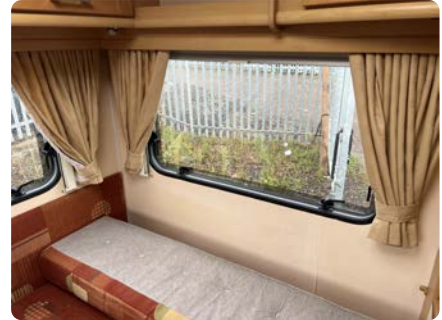
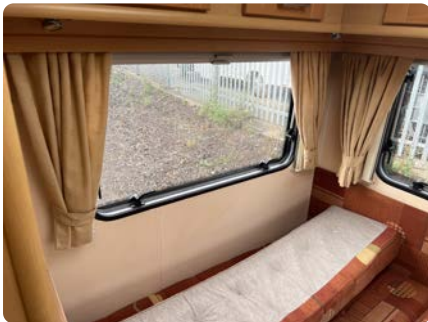
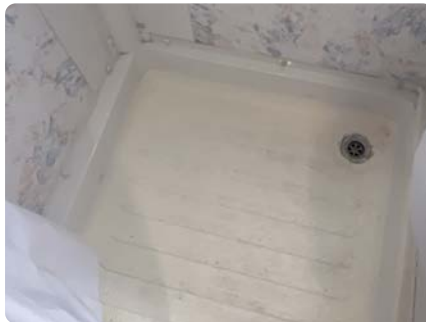
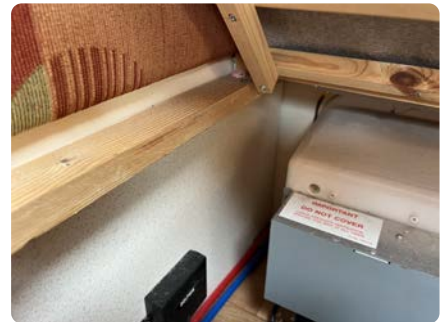
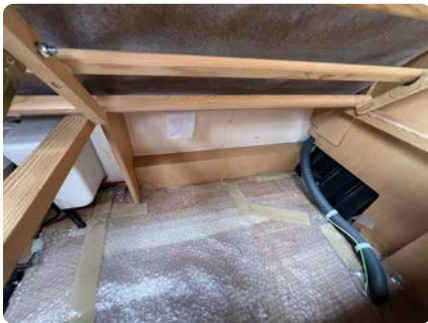
Internal Damage	Yes
Damage Info	All walls painted magnolia @ kitchen walls wrapped // previous shower tray repair // over boarding on rear wall under seats // box section fitted under NS bench
Damp Visible/Soft	Yes
Damp Info	Staining in bathroom roof
Floor Damp/Spongy/Damaged	Yes
Floor Info	Small area slightly spongy in front of heater
Manuals Present	Yes
