CMS MOTORHOME INSPECTION FORM

Make & Model	Lunar Roadstar EL
Reg Number - NO GAP	PX18BDE
HPI Clear	Yes
VAT	No
Engine Size	2.3
BHP	0
Transmission	Automatic
Miles or KM	Miles
Mileage	17091
Confirm miles (within 5,000)	Yes
Is Mileage Warranted	Yes
Engine Keys Count	
V5 present	Yes

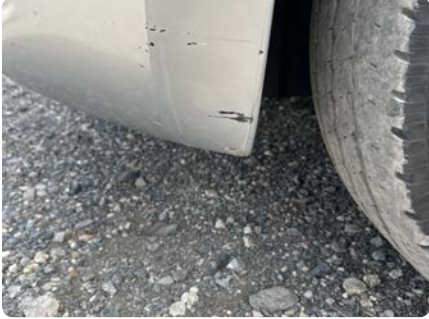
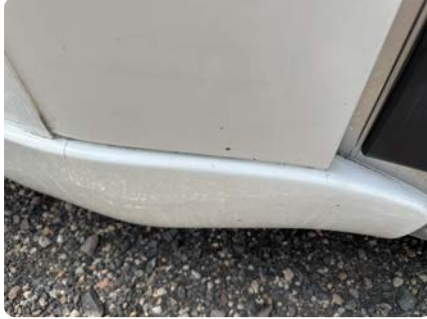
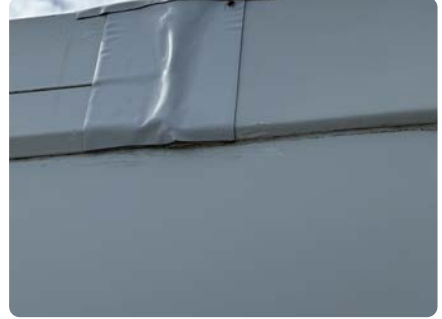
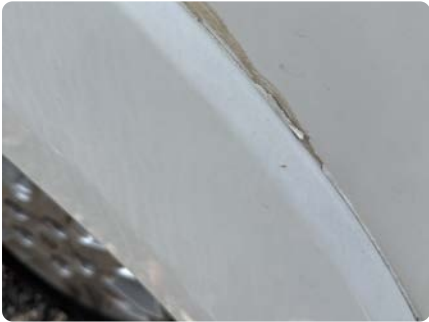
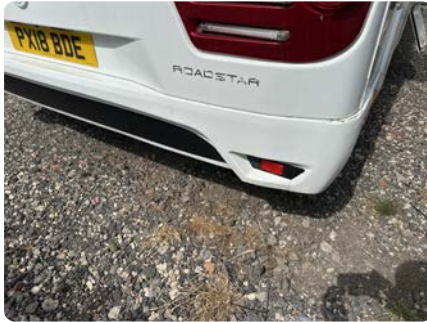
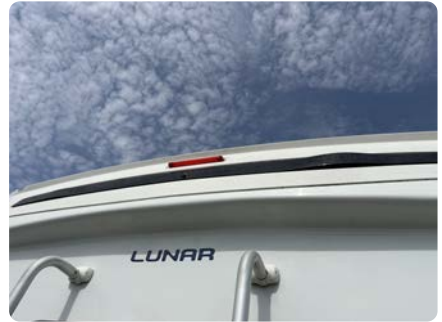
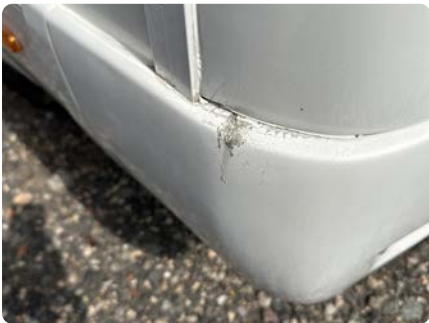
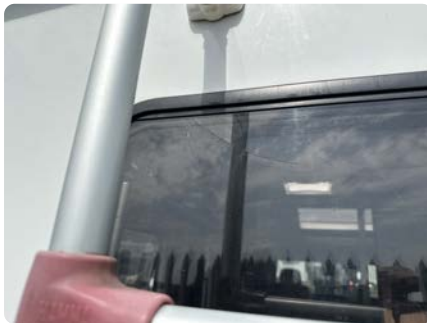
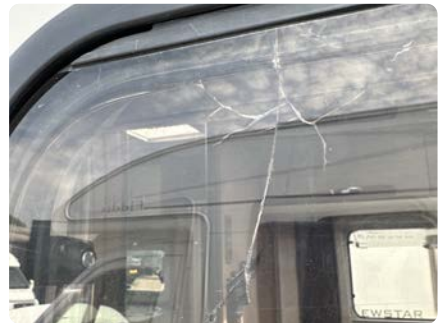
External Damage Photos

External Extras	Alloys, Awning, Bike Rack, Reversing camera, Tv Aerial, Solar panel, Front fog lights
Decals	Need attention
Decals Further Info	Offside decals peeling
Any Damage Found	Yes
Damage Further Info	Crease above N/S window // N/S/F bumper scuffed // Crease on bonnet // Crack in O/S trim by drivers door // Damage O/S roof // Paint peel O/S/R wheel arch // Crack in O/S/R bumper // Rear trim bulging // Damage to N/S/R bumper corner // Crack in rear window and N/S/R side window // Crack in nearside trim behind passenger door // Paint peel above passenger door on overhead
Windscreen	No damage
Alloy Wheels	Need attention
Alloy Wheels Further Info	Alloys bubbling offside front, nearside rear.
Tyres Illegal/Cracking/Out of Date	Yes
Tyre Further Info	All dated 32/15. Roadworthy.
Damp Floor Underneath	Yes
Damp Further Info	O/S rear corner
Electric Step	N/A
Self Levelling Work	N/A
Pop Top Canvas Damage	N/A

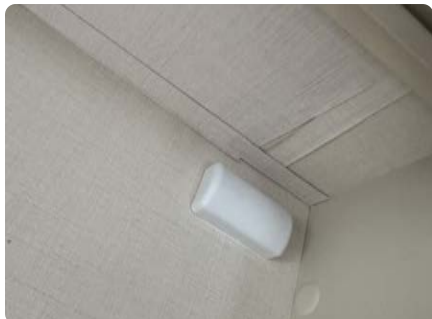
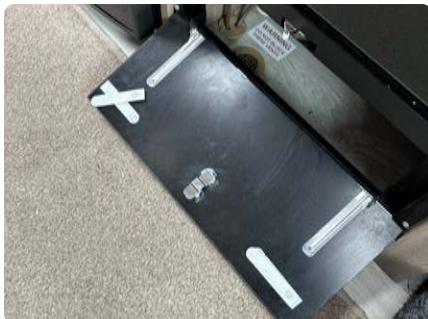
Internal Damage Photos

Internal Damage	Yes
Damage Info	Wallpaper is worn in some of the N/S overhead lockers // Catch broken below oven
Damp Visible/Soft	Yes
Damp Info	O/S wall in cupboard soft
Floor Damp/Spongy/Damaged	No
Manuals Present	Yes
