CMS MOTORHOME INSPECTION FORM

Make & Model	Lunar Newstar 58
Reg Number - NO GAP	WP55OMG
HPI Clear	Yes
VAT	No
Engine Size	2.0
BHP	127
Transmission	Manual
Miles or KM	
Mileage	60098
Confirm miles (within 5,000)	Yes
Is Mileage Warranted	Yes
Engine Keys Count	
V5 present	Yes

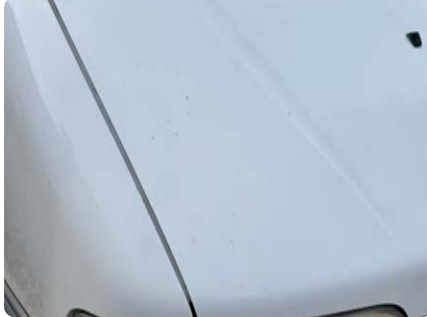
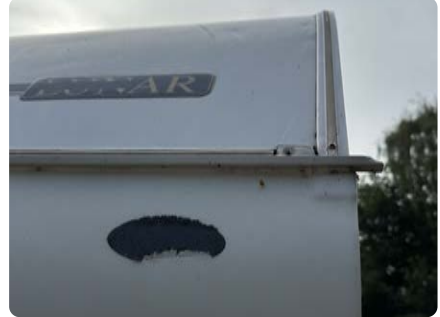
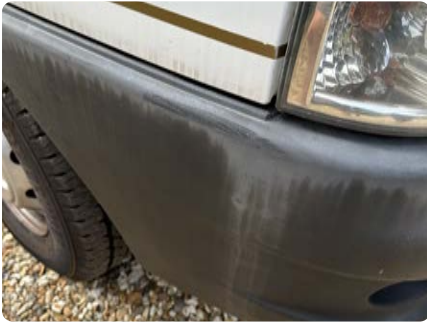
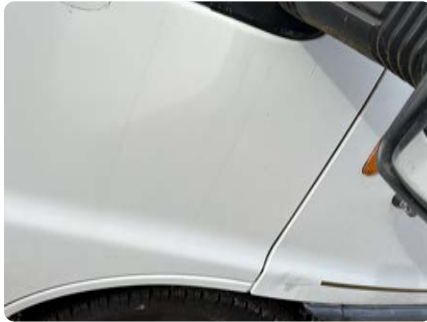
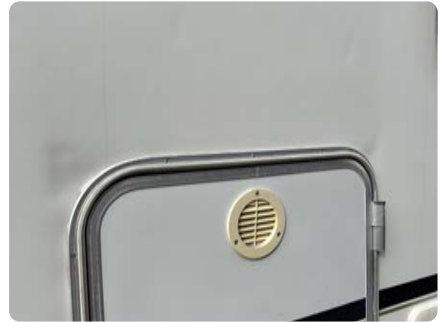
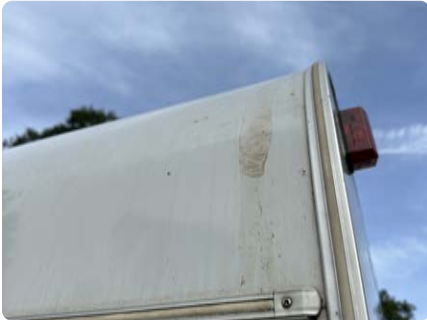
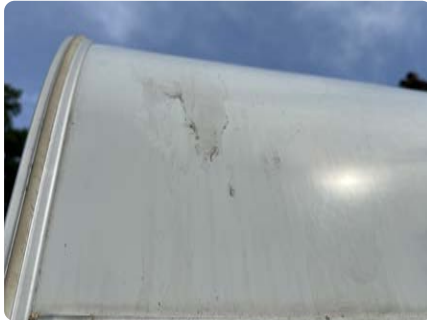
External Damage Photos

External Extras	Awning, Manual step, Habitation door lock, Parking sensors, Gaslow
Decals	Need attention
Decals Further Info	Decals on N/S/R and O/S/R and overcab are faded and peeling
Any Damage Found	Yes
Damage Further Info	Crack on front of awning // Paint peel on bonnet // Dinks on N/S overcab // Scrape on O/S/F front bumper // Dent above O/S/F wheel arch and scratch on driver door // Two areas of delamination on O/S next to gas locker door // Two repairs on rear top O/S and N/S // Crack on N/S/R bumper corner // Dent above N/S/F wheel arch
Windscreen	No damage
Alloy Wheels	N/A
Alloy Wheels Further Info	
Tyres Illegal/Cracking/Out of Date	No
Tyre Further Info	
Damp Floor Underneath	Yes
Damp Further Info	Dry rot under N/S O/S and rear sill
Electric Step	N/A
Self Levelling Work	N/A
Pop Top Canvas Damage	N/A

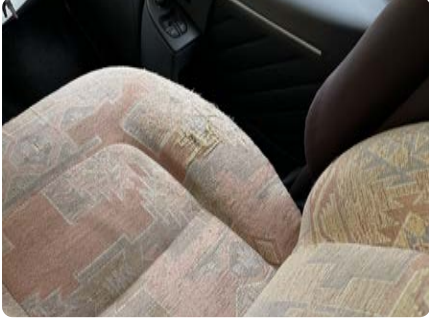
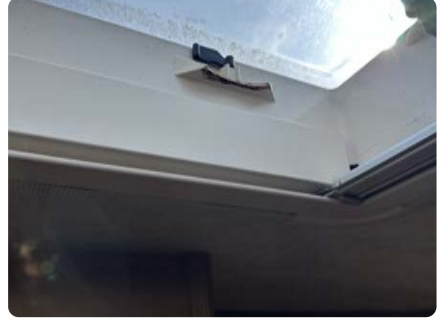
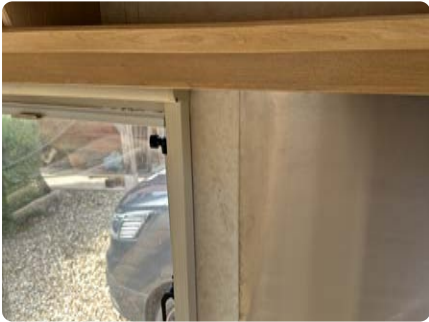
Internal Damage Photos

Internal Damage	Yes
Damage Info	Tear on driver seat // Damage to bathroom door // Crack on skylight clip // Metal plate on N/S wall
Damp Visible/Soft	Yes
Damp Info	Soft wall N/S overcab // Soft N/as wall bed to habitation door // Soft and pimpling N/S wall next to N/S/R window // Soft wall in front of N/S/R wheel arch // Dry rot around N/S/R locker // Soft O/S wall under bench seat // Roof is soft and is sagging at rear // Roof is pimpling in kitchen area
Floor Damp/Spongy/Damaged	Yes
Floor Info	Floor is soft under bench seat O/S/R
Manuals Present	Yes

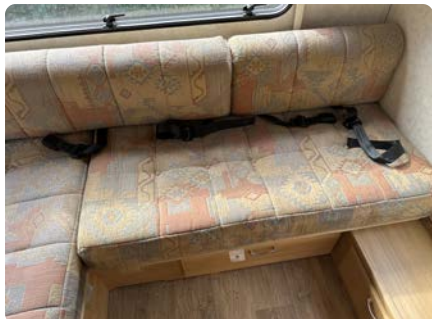
Photo 1

Internal Look Original	
Berths	4
Belts	4
Bed Options	L Shape Rear, Overcab Bed
Lounge Layout	L-Shaped rear lounge
Layout Correct	Yes
Further Comments	Yes
Further Comments Info	Two rear belts are lap belts
Internal Extras	Cab curtains, Oven
Other Extras	
Electrics Turn On	No
More Info	Leisure Battery needs fitting
Control Panel Damaged	
More Info	
Stereo Turn On	No
Smell or Signs of Smoking	No
Cushions Correct	Yes
Boiler Present	Yes
Overhead Lockers Ready	Yes
