CMS MOTORHOME INSPECTION FORM

Make & Model	Elddis Autoquest 194
Reg Number - NO GAP	J90LXY
HPI Clear	Yes
VAT	No
Engine Size	2.0
BHP	130
Transmission	Manual
Miles or KM	Miles
Mileage	22160
Confirm miles (within 5,000)	Yes
Is Mileage Warranted	Yes
Engine Keys Count	
V5 present	Yes

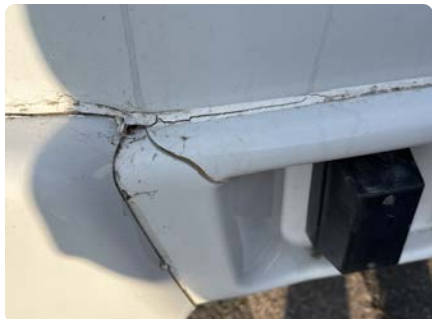
Photo 1

External Extras	Solar panel, Tv Aerial, Reversing camera, Awning, Habitation door lock
Decals	Good
Decals Further Info	
Any Damage Found	Yes
Damage Further Info	Crack in rear bumper // Small dink on door // Small area of paint flake on bonnet and O/S a-pillar
Windscreen	No damage
Alloy Wheels	N/A
Alloy Wheels Further Info	
Tyres Illegal/Cracking/Out of Date	No
Tyre Further Info	
Damp Floor Underneath	No
Damp Further Info	
Electric Step	N/A
Self Levelling Work	N/A
Pop Top Canvas Damage	N/A

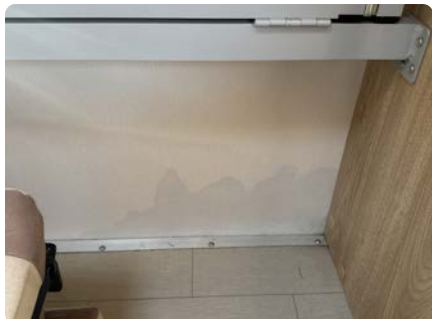
Photo 1

Internal Damage	No
Damp Visible/Soft	Yes
Damp Info	99% and stained n/s bench seat // staining o/s bench seat // 99% stained and pimpled next to battery box // n/s garage door stained
Floor Damp/Spongy/Damaged	No
Manuals Present	Yes
