CMS MOTORHOME INSPECTION FORM

CMS Motorhome Inspection	
Make & Model	
Reg Number - NO GAP	
HPI Clear	
Engine Size	
BHP	
Transmission	
Miles or KM	
Mileage	
Confirm miles (within 5,000)	
Is Mileage Warranted	
How many sets of engine keys	
V5 present	
Does the V5 vin match 2 x Vehicle vins

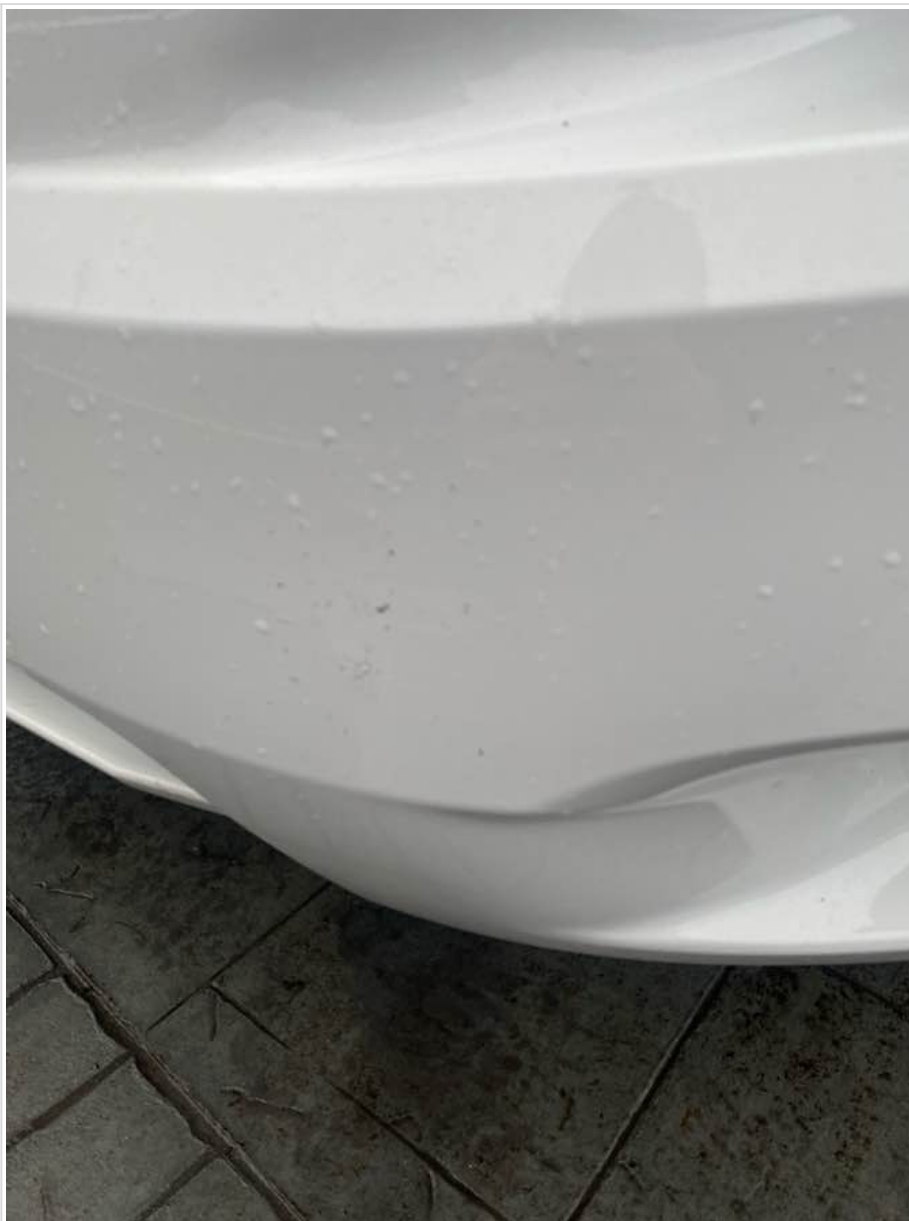
Damage Photos

External Extras	
Any Other Extras	
Decals	
Further Info	
Decal Photos	
Any Damage Found	
Further Information

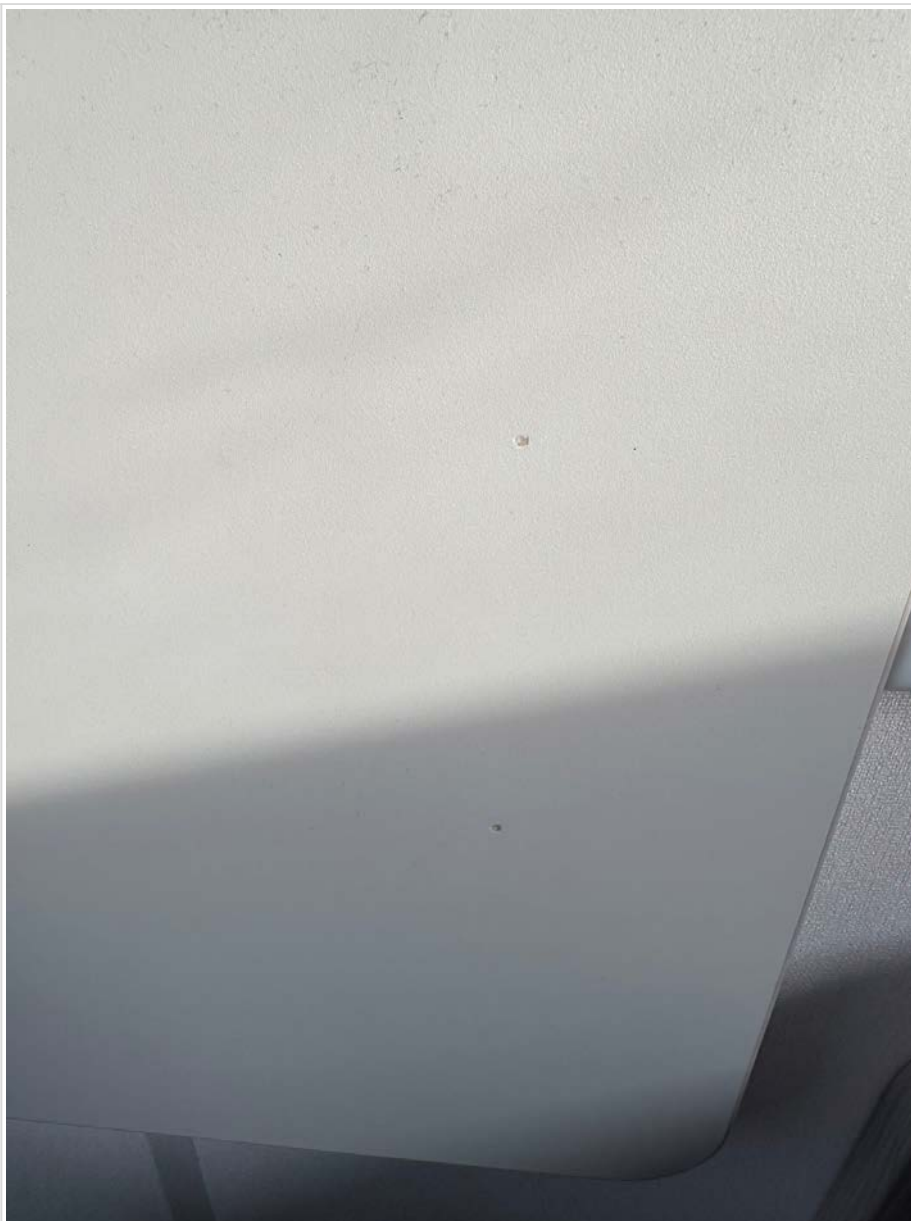
Damage photos

Internal Extras	
Other extras	
Do the electrics turn on	
More info	
Control Panel Damaged? Screen/buttons	
More Info	
Does the stereo turn on	
Smell or signs of smoking	
Are all cushions correct including travel cushions	
Is the boiler present	
Are overhead lockers empty/objects secure ready for travel?	
Damage	
Damage info

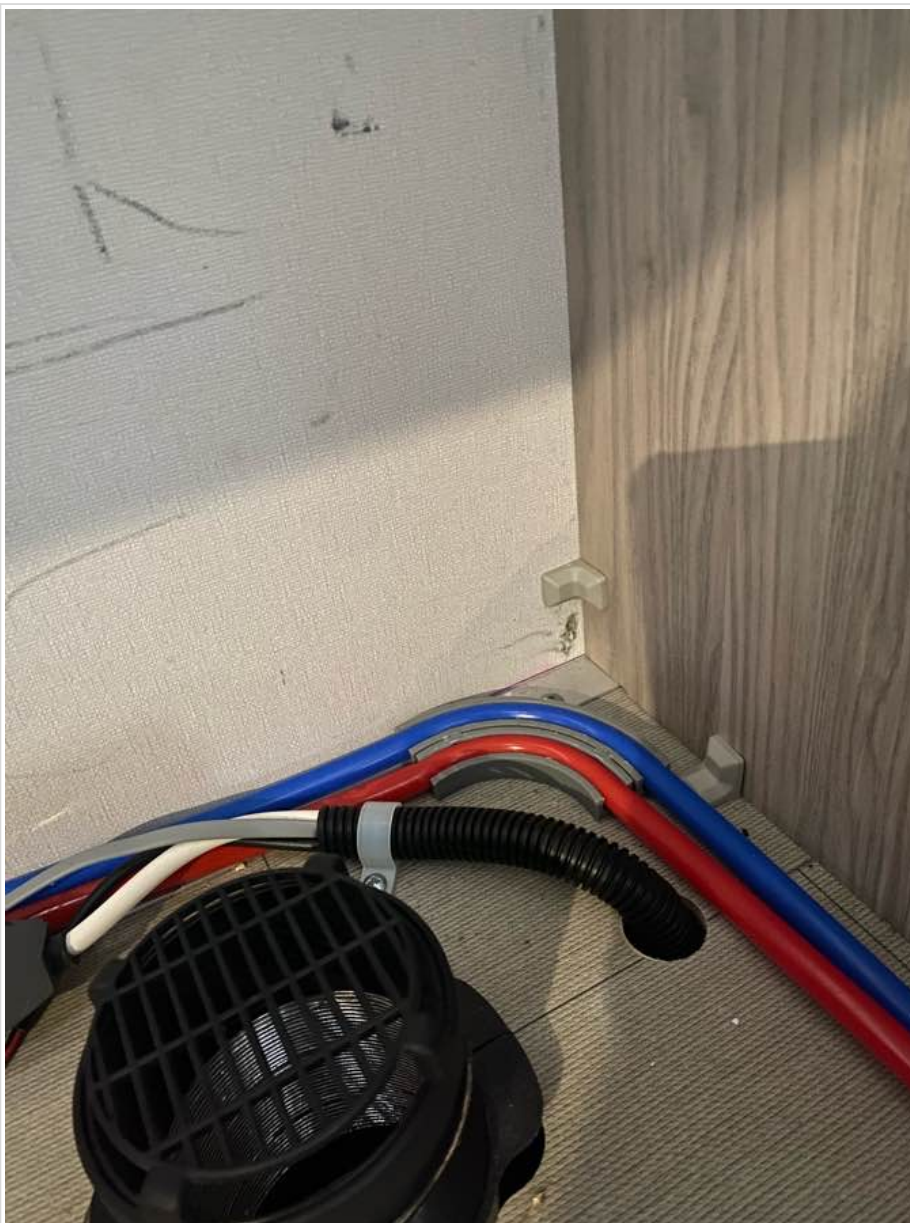
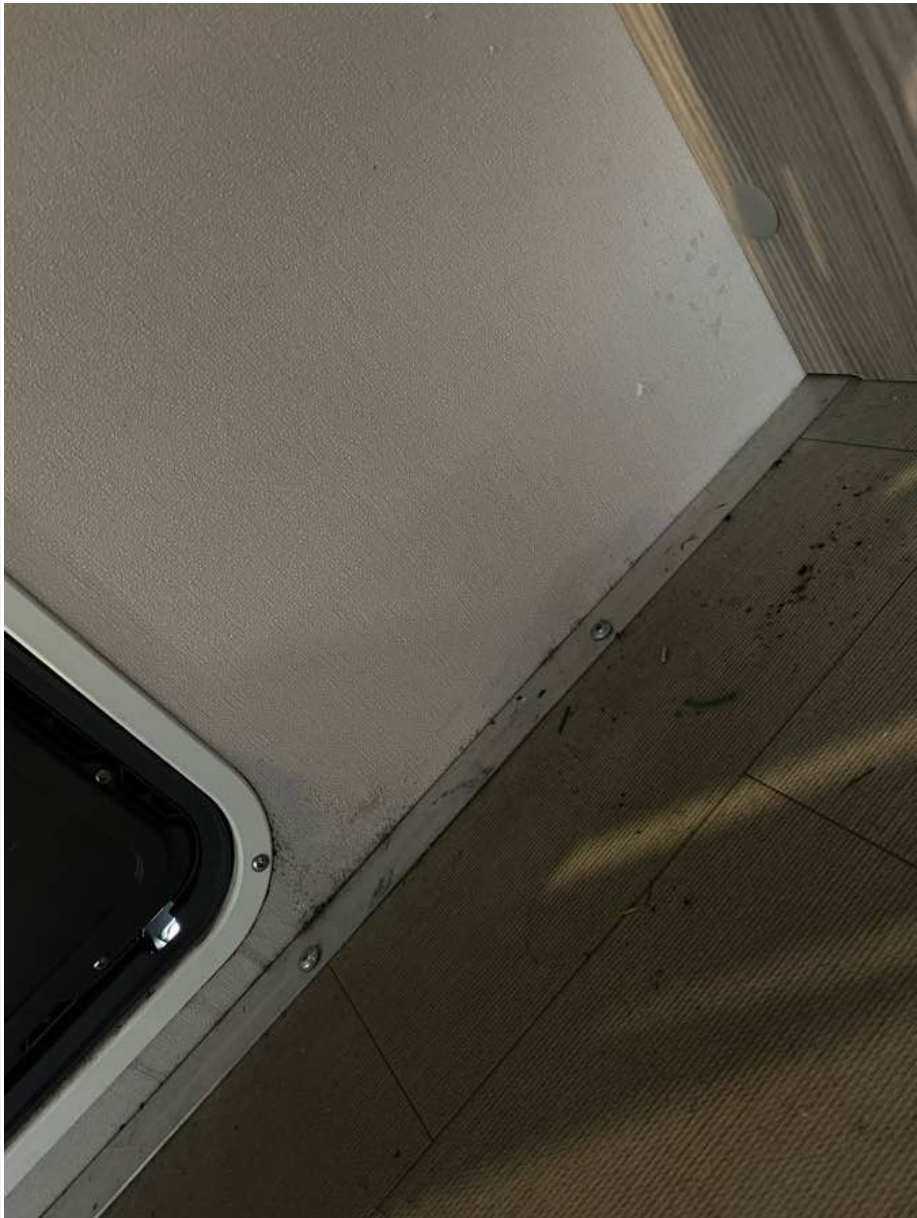
Photos of any damp

Damp (visible/Soft)	
Damp info

Floor damp/spongey/damaged	
Further info	
Floor photos

Visual inspection possible with Protonmeter
- Damp found on floor under front offside bench seat by battery box and passenger area and readings found under driver's side bathroom - seek to repair

- Damp board on floor in two areas (see report).
- Install fire extinguisher if not already installed.
- No other faults found.

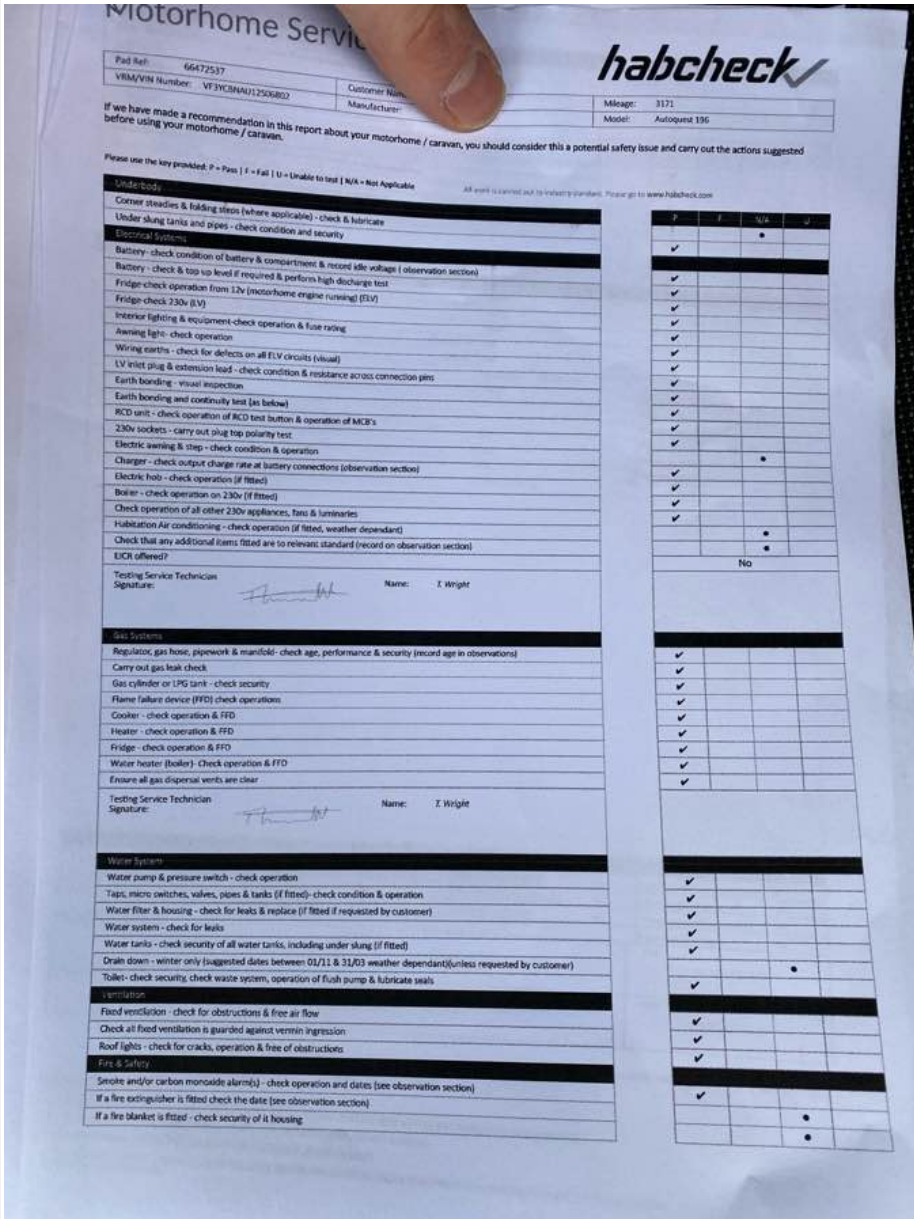
Has the cam belt been changed? (5 years on all ford 2.0 and fiat 2.3)	
Cam belt change info	
Cam belt change invoice	
Habitation Service Reports	
Habitation service info	
Habitation service photos
