CMS MOTORHOME INSPECTION FORM

Make & Model	Bailey Approach Autograph 625
Reg Number - NO GAP	WJ16OWM
HPI Clear	Yes
VAT	No
Engine Size	2.2
BHP	130
Transmission	Manual
Miles or KM	
Mileage	20798
Confirm miles (within 5,000)	Yes
Is Mileage Warranted	Yes
Engine Keys Count	
V5 present	Yes

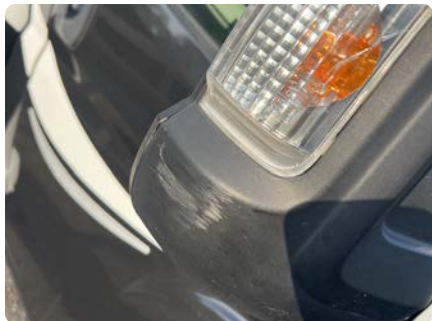
Photo 1

External Extras	Bike Rack, Tow bar, Reversing camera, Awning, Satellite dome
Decals	Need attention
Decals Further Info	overcab decal lifting in areas
Any Damage Found	Yes
Damage Further Info	Scuff to OS mirror
Windscreen	Chip(s) smaller than 10p
Alloy Wheels	N/A
Alloy Wheels Further Info	
Tyres Illegal/Cracking/Out of Date	Yes
Tyre Further Info	Dated 2015
Damp Floor Underneath	
Damp Further Info	
Electric Step	N/A
Self Levelling Work	N/A
Pop Top Canvas Damage	N/A

External Damage Photos

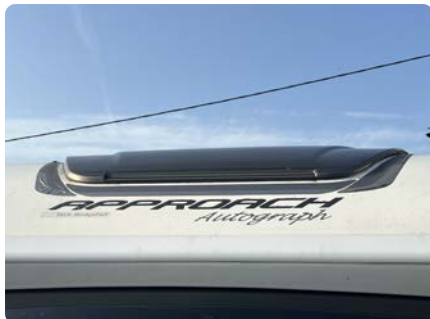
Photo 1

Decal Photos

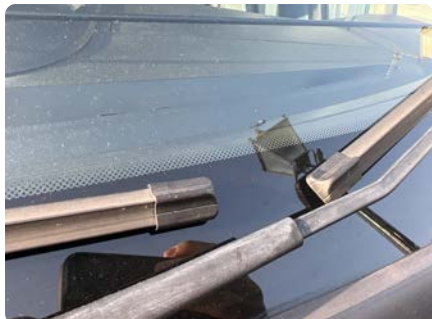
Photo 1

Windscreen Damage Photos

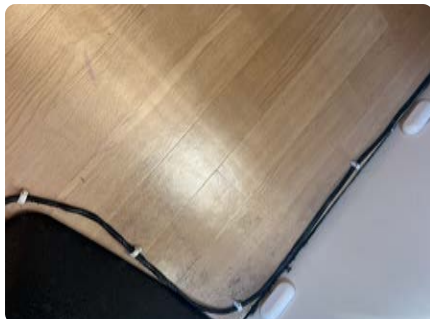
Photo 1

Internal Damage	No
Damp Visible/Soft	No
Floor Damp/Spongy/Damaged	Yes
Floor Info	Floor stained and soft under NSR bench // floor slightly soft behind OSR arch
Manuals Present	Yes

Floor Photos
