CMS MOTORHOME INSPECTION FORM

Make & Model	Elddis Prestige 125
Reg Number - NO GAP	YJ16BRV
HPI Clear	Yes
VAT	No
Engine Size	2.0
BHP	130
Transmission	Manual
Miles or KM	Miles
Mileage	29585
Confirm miles (within 5,000)	Yes
Is Mileage Warranted	
Engine Keys Count	
V5 present	Yes

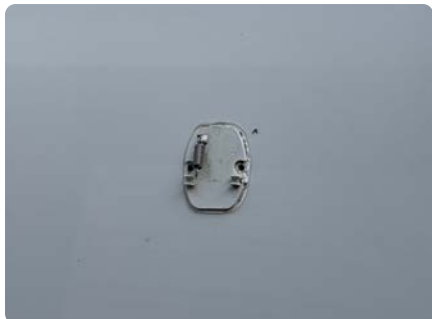
Photo 1

External Extras	Gaslow, Satellite dish, Reversing camera, Awning, Solar panel
Decals	Good
Decals Further Info	
Any Damage Found	Yes
Damage Further Info	Clip for rear tailgate broken // laquer peel on o/s rear corner panel // sat dish damaged on edge
Windscreen	No damage
Alloy Wheels	N/A
Alloy Wheels Further Info	
Tyres Illegal/Cracking/Out of Date	No
Tyre Further Info	
Damp Floor Underneath	No
Damp Further Info	
Electric Step	N/A
Self Levelling Work	N/A
Pop Top Canvas Damage	N/A

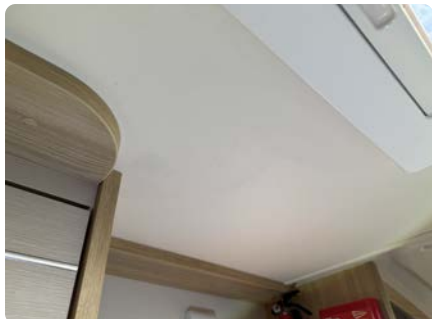
Photo 1

Internal Damage	No
Damp Visible/Soft	Yes
Damp Info	Very light Staining around the front skylight not reading // 77% in wall under kitchen // 33% and light stain in dinette wall behind drivers seat
Floor Damp/Spongy/Damaged	No
Manuals Present	Yes
